Mr. & Mrs. Flowers
EZflow Multiple Trench
Raised bed, pumped
~3 years old

Mr. & Mrs. Flowers - Raised-bed, pressure-dosed drainfield.

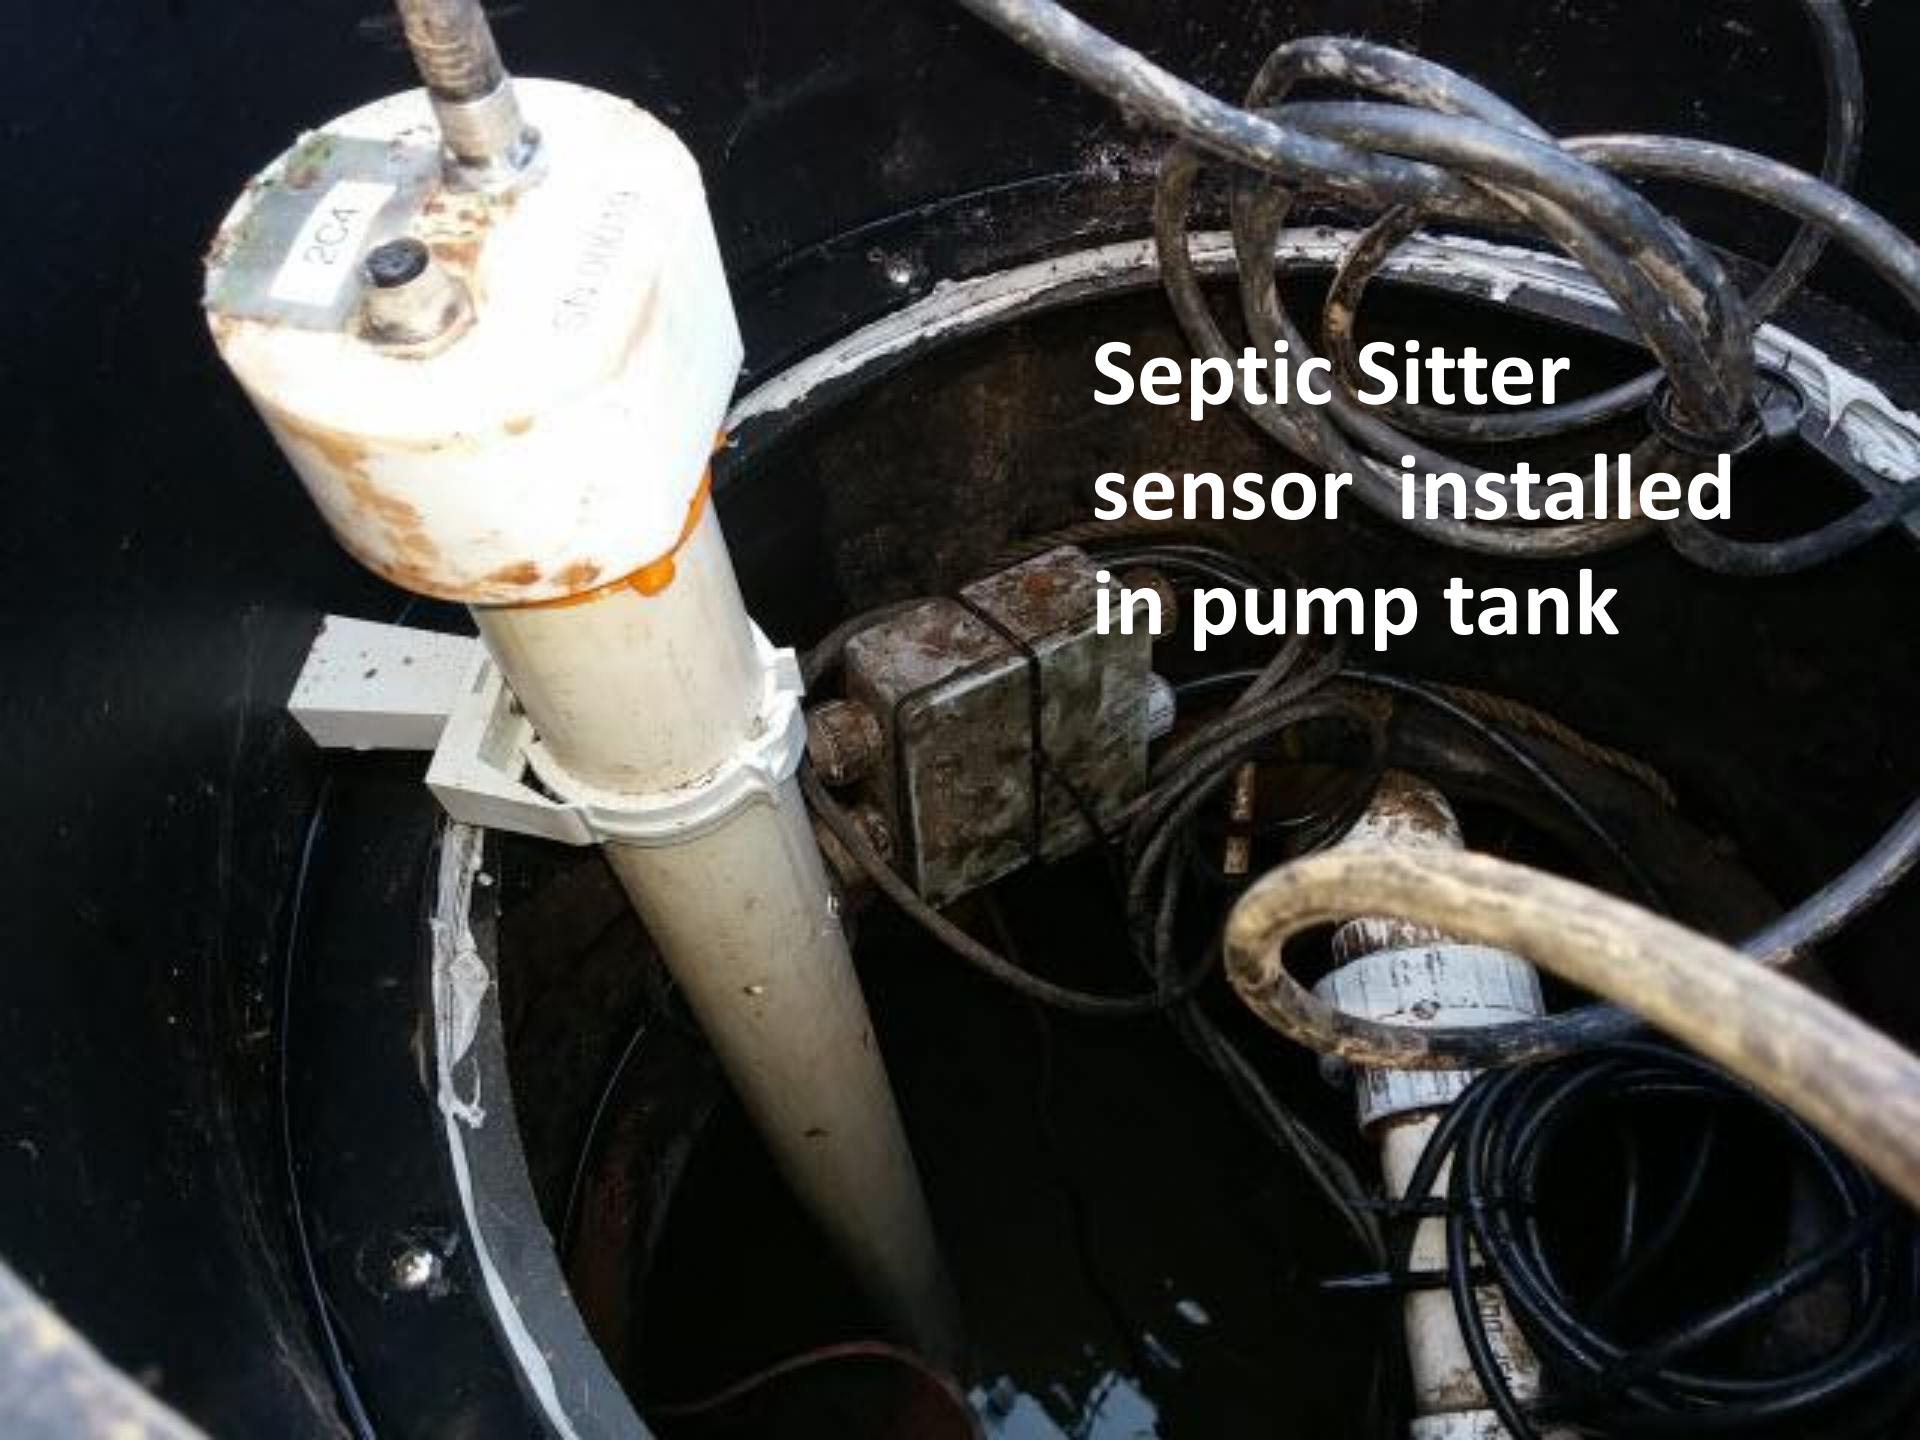
A photograph showing a white, cylindrical "Septic Sitter" sensor installed in a dark, confined space, likely a pump tank. The sensor has a white cap with a label that reads "2C4". It is secured with a white plastic bracket. Various black cables and a metal pipe are visible in the background.

**Septic Sitter
sensor installed
in pump tank**

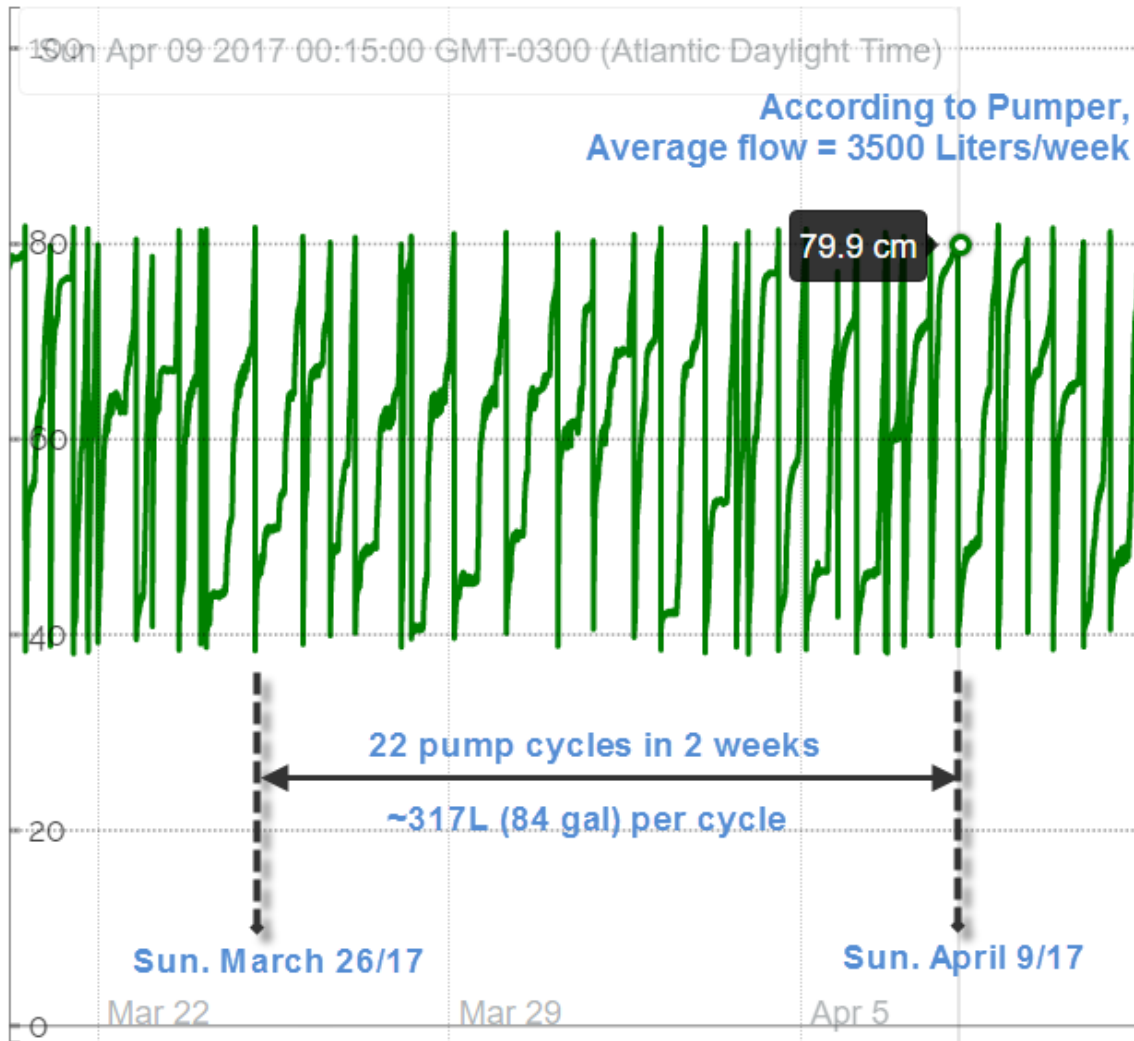
Septic Sitter data used to determine number of pump cycles in a 2 week period, and estimate the volume per pump cycle (dose)

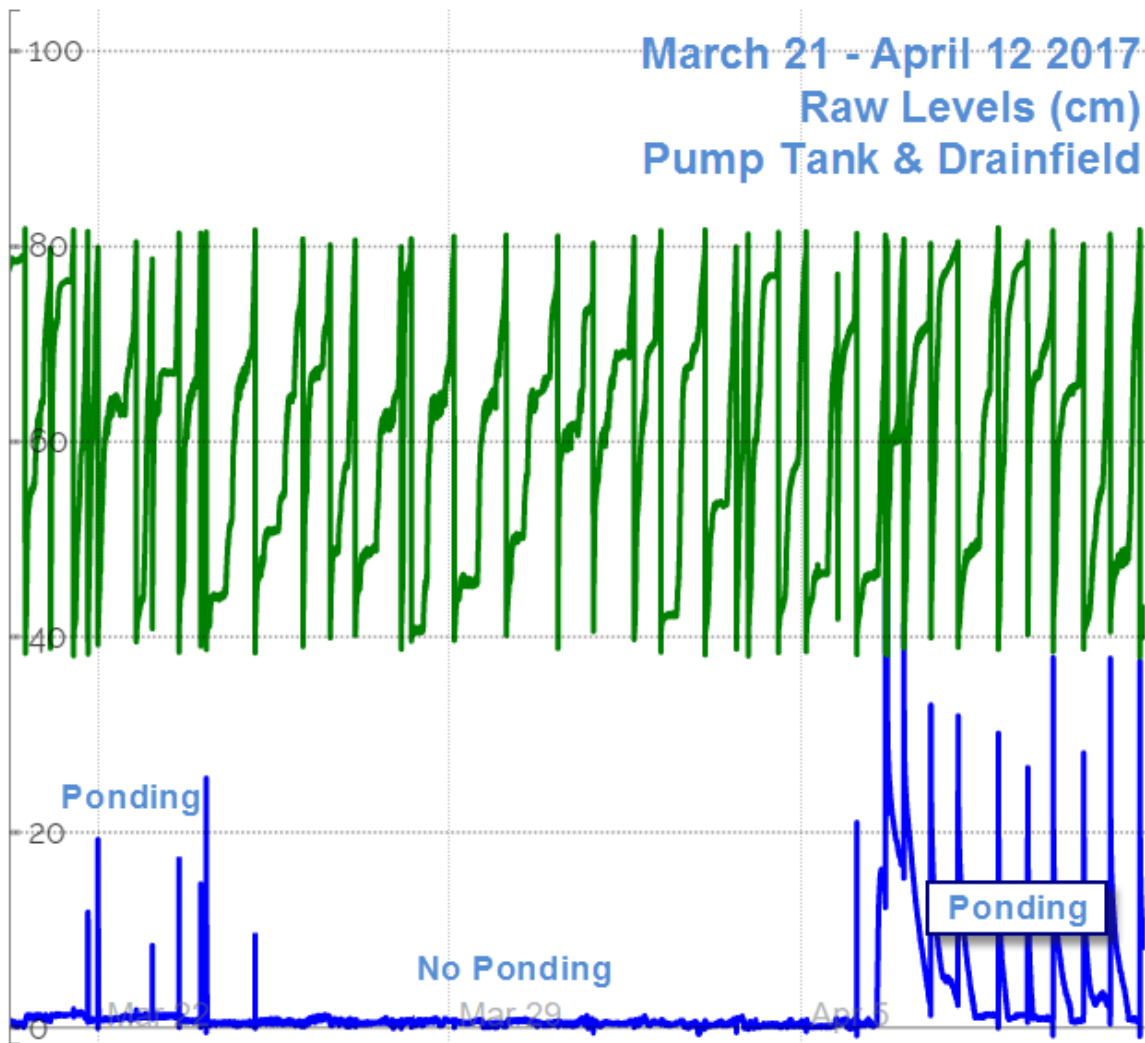
Significant variation in trench ponding levels has been observed. Sometimes levels approach the ground surface, while other times there is no ponding at all.

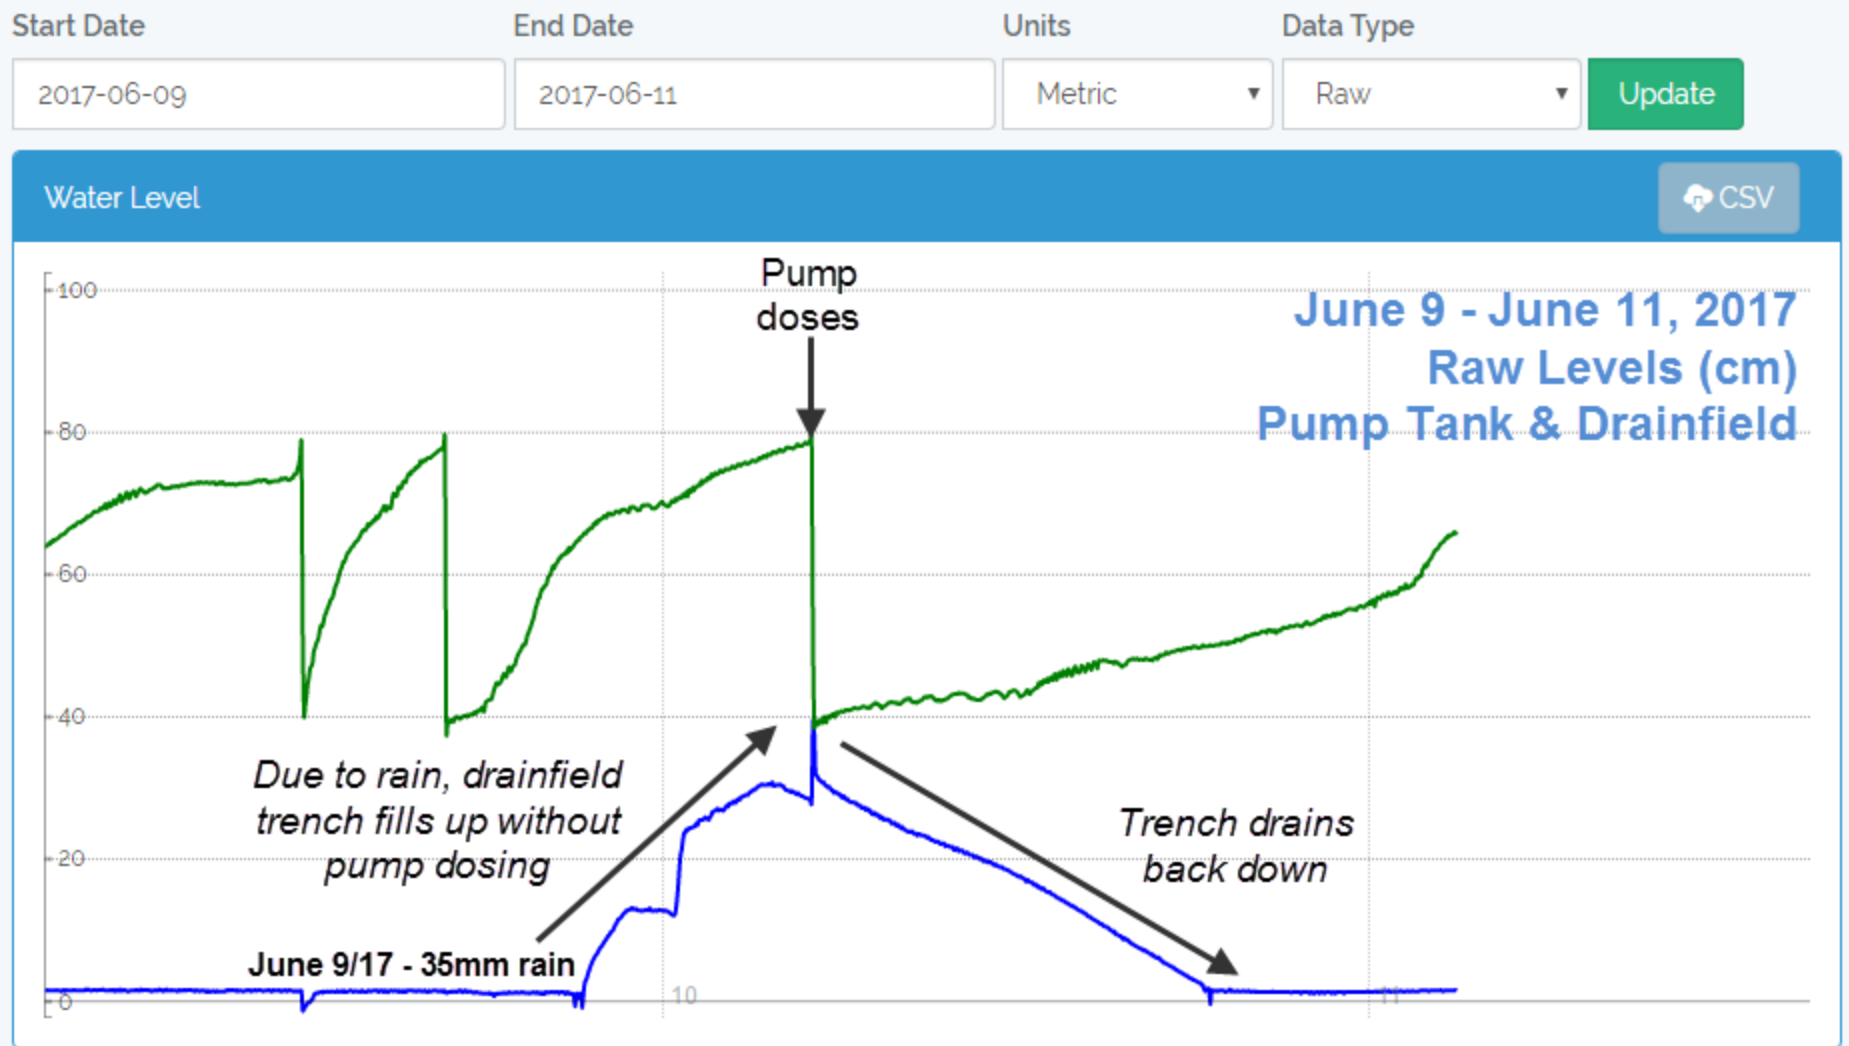
Poor surface grading causing trench to pond from rainfall

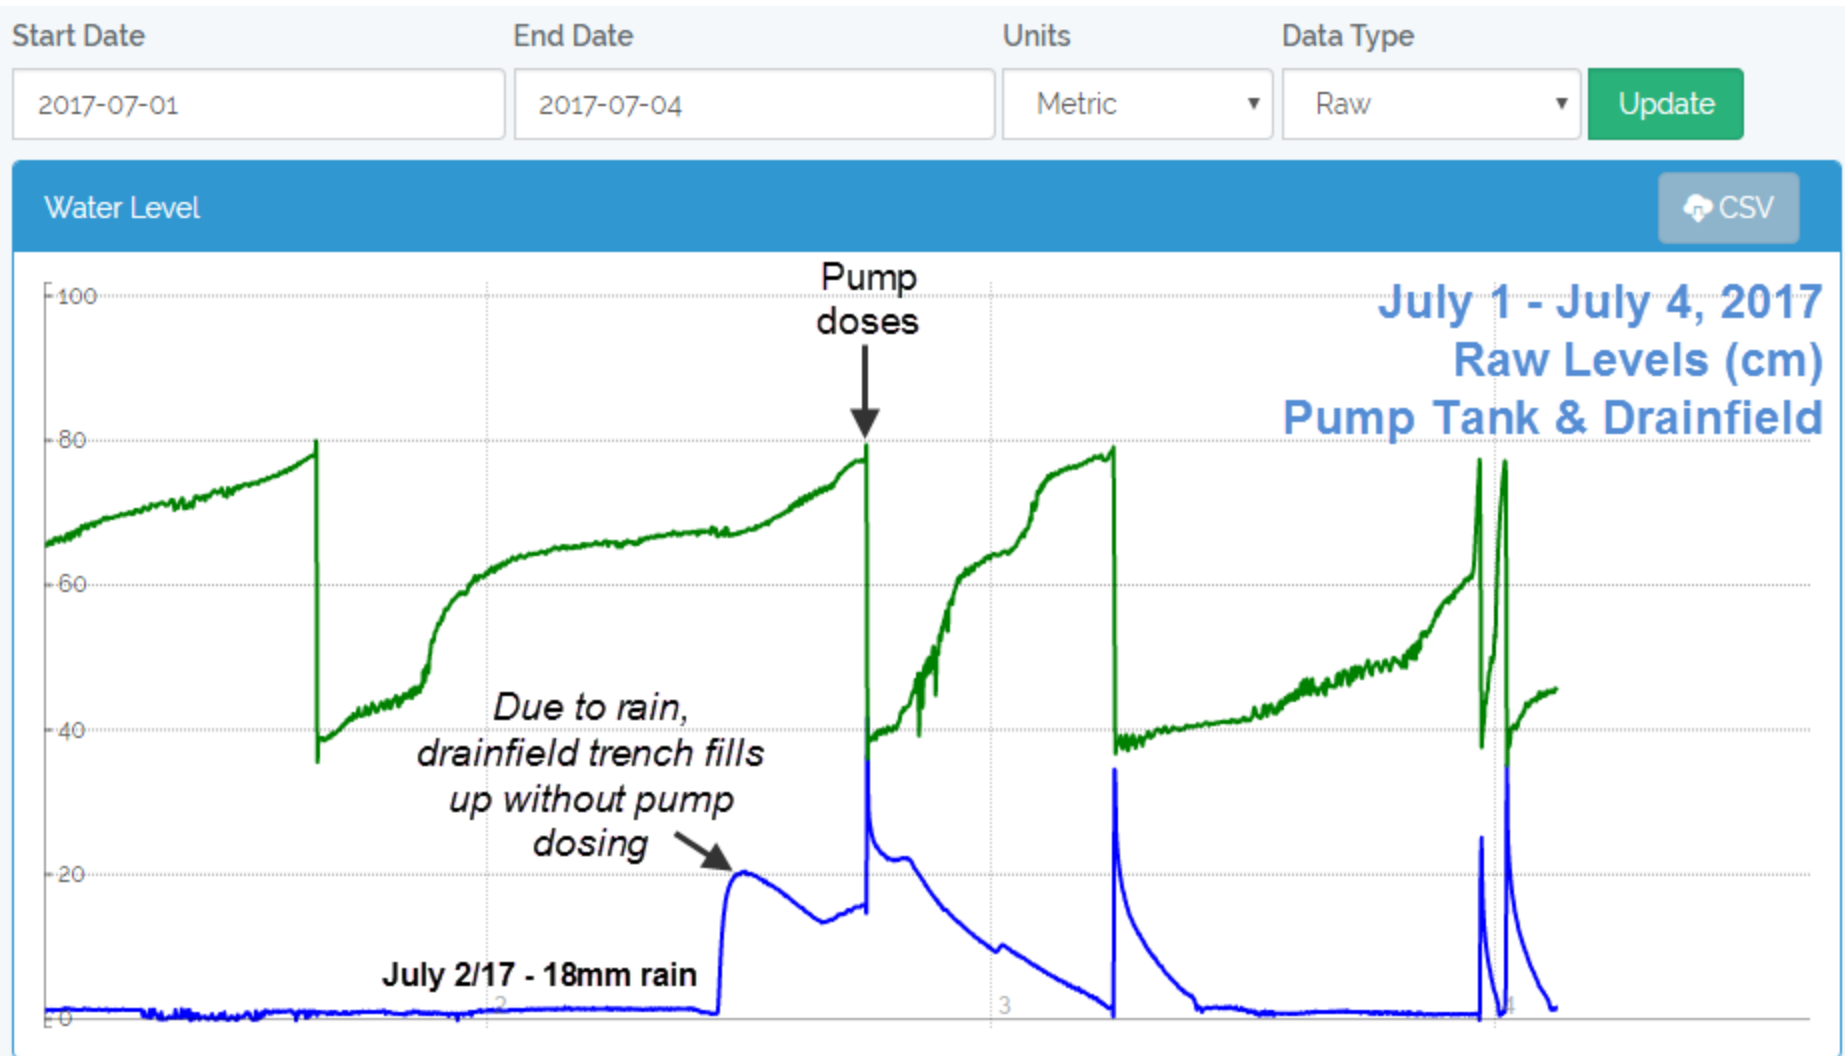
Poor surface grading causing trench to pond from rainfall
